Human Lethality From A Suicide Bomber Bus Event

by Brad Lauritsen, P.E.

The simulated suicide bomber event took place on November 13th, 2007, in San Bernardino, California at a range used by the San Bernardino Bomb Squad. Applied Research Associates (ARA) was invited by the Orange County Sheriff's Department to participate in the Golden Guardian exercise to gather scientific data from this simulated suicide bomber on a city bus and provide preliminary injury predictions. ARA's data collection effort for this test was sponsored by the Technical Support Working Group (TSWG), and was undertaken as the first step in the development of a prediction tool to evaluate and prioritize victims (inside and outside the bus), define extended damage radius to buildings and equipment, and define expected response requirements for law enforcement and first responders after an attack from a suicide bomber on a bus.

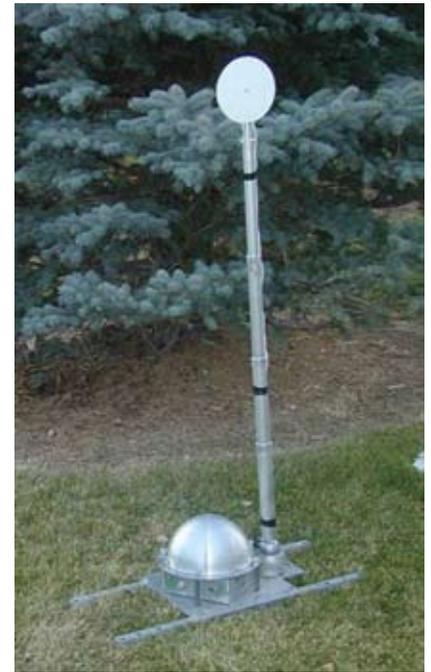
Instrumentation used in the testing included two high-speed digital video cameras, three free-field (outside of the bus) pressure gauges, and two Ironman Blast Dummy instrumentation systems. The pressure gauges used outside the bus are called MARS (Measure Airblast Remote Station) Probes (Figure 1). These are high-speed blast/acoustic, semi-hardened, measuring systems developed by ARA and customized for specific remote applications.

Figure 1. MARS Probe

Pressure gauges (MARS probes) were placed outside the bus at distances of 10, 16 and 23 ft (~3, 5, and 7 meters) from the bomber (Figure 4). The outside mannequins were placed at the same radial distance from the charge as the pressure gauges. Distance markers were placed at 10-foot (3-meter) intervals to estimate debris speed from the video footage.

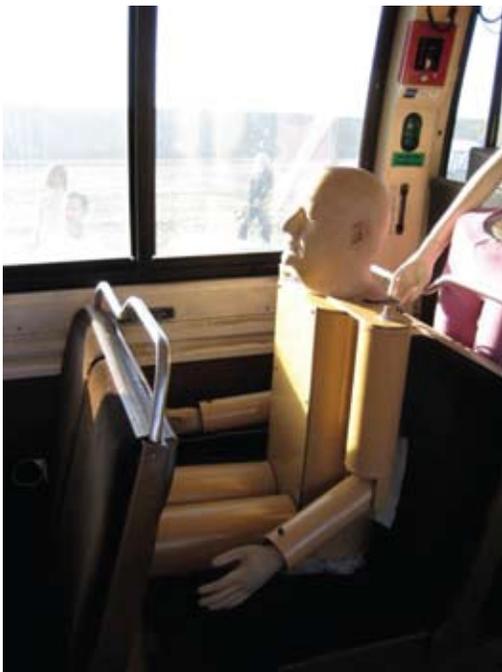
Figure 2. Iron Man with Silicone Head

Two Ironman systems (Figure 2, Figure 3) were used as human surrogates. Ironman is designed to have the equivalent height, mass distribution, and general body shape factor as a 50th percentile human male in order to measure environmental loads on the human body. Both Ironman systems had articulating arms and legs so they could be seated in the bus and give them more realistic reactions to the blast.

Each Ironman typically has four pressure gauges installed in the thorax: one on the front, one on the back, and one on each side. For this test, no gauge was used on the back. Miniature data acquisition systems (miniDAS), developed by ARA, are installed in each Ironman to record the pressures and the data is stored on a flash card.

One Ironman was placed in the back seat of the bus, and the other closer to the middle, near the bomb. The Ironman in the rear had a camera in its head to capture video of the event (Figure 3). The Ironman closer to the bomb, seated just in front of the rear door, had a silicone rubber head

that acted as a tissue surrogate for assessing fragment injuries. (Figure 2).

After the test, the Ironman systems were removed and examined for signs of potential injury. It was apparent that they had both been struck by numerous fragments, from both the bus and the nails in the device. The silicone head Ironman had a large gouge in his lower abdomen from a nail, and also a large cut in the top of his head. He also had numerous small fragments embedded in his head. The camera head Ironman also had numerous chips and scratches on his chest and legs. The fiberglass mannequins outside the bus were also examined and they all exhibited some signs of injury, mostly by small fiberglass and metal fragments from the bus.

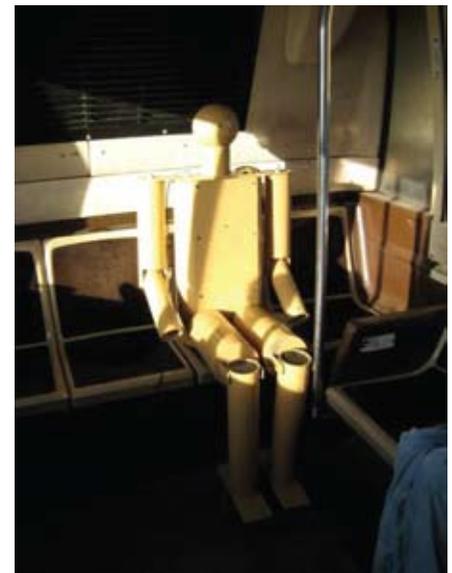
Figure 3. Iron Man with Camera Inside Head

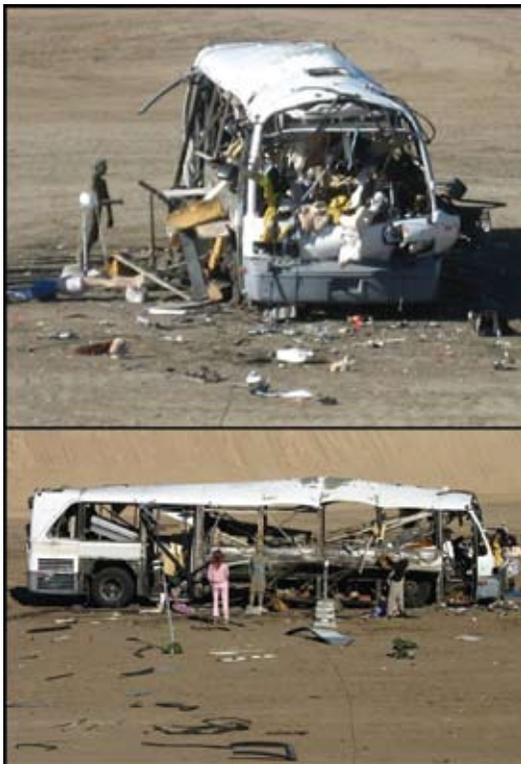
Figure 5 shows the bus after the explosion. All of the windows were blown out, as well as the windshield. The roof was bulged outward, but did not depart the bus. Large pieces of the exterior side panels came off, and the front door was completely removed. Inside the bus, the ceiling collapsed and the walls were completely ripped off (Figure 6). All of the material from the seats had been torn away by the blast, leaving only the metal frames. The floor was blown downward, and severely buckled. The blast did not displace the bus from its original position.

Figure 5. Bus Exterior After Explosion

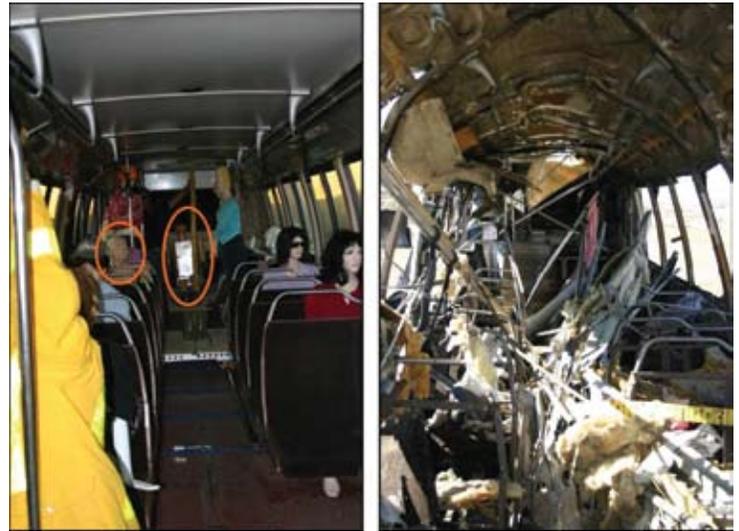
Figure 6. Before and After Photos of Bus Interior
